Moose Pond

Prepared by Heather True March 2011

Moose Pond 2010 Watershed Survey

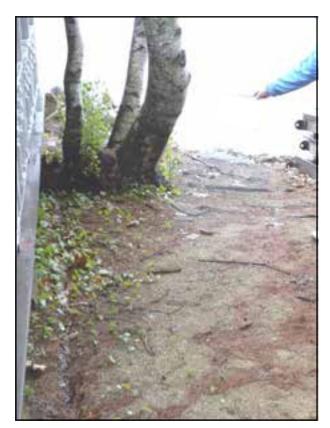
The erosion problems associated with the property pictured at left were common on many other properties within the watershed.

- Plant native plants.
- Mulch bare areas.
- Infiltrate or redirect runoff above shoreline.
- Stop raking.
- Create defined foot paths.

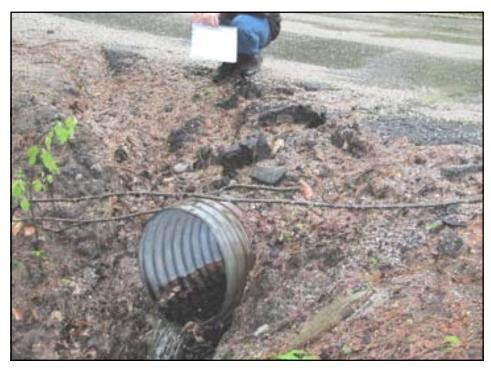
The erosion problems associated with the town road pictured below were common on many other roads throughout the watershed.

Problems:

- Unstable culvert inlet and outlet.
- Moderate road shoulder erosion.

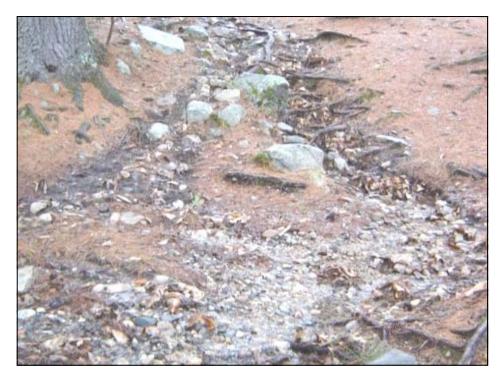
The erosion problems associated with the commercial site pictured below were common on many other sites throughout the watershed.

Problems:

- Erosion from high concentrated water flows.
- Bare soil, exposed roots.

- Divert and infiltrate stormwater uphill of erosion site using water diverters and native shrubs.
- Create defined walkways.
- Cover areas of bare soil with erosion control mulch.
- Use strategic plantings to divert water flow and define walking paths.

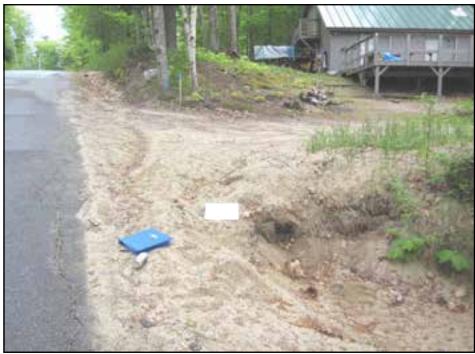
The erosion problems associated with the driveway pictured below were common on many other driveways within the watershed. Runoff from this driveway is also contributing to road shoulder problems.

Problems:

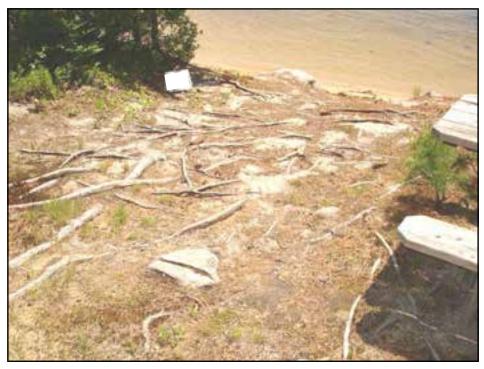
The erosion problems associated with the beach access site pictured below were common on many other shorelines within the watershed.

Problems:

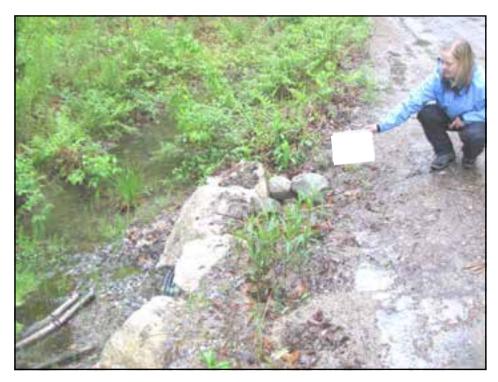
The erosion problems associated with the private road pictured below were common on many other roads within the watershed.

Problems:

- Add new / proper road surface material.
- Reshape and crown road.
- Install runoff diverters or turnouts to direct water to areas where it will infiltrate.
- Stabilize road shoulder with riprap.

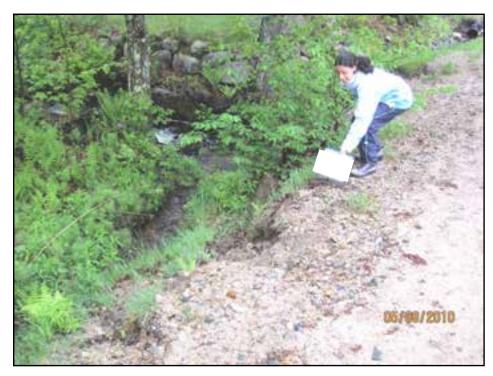
The erosion problems associated with the state road pictured below were common on many other roads within the watershed.

Problems:

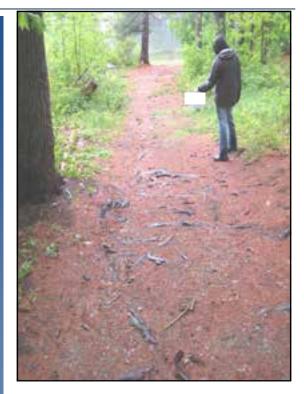
The photo above shows a wide path leading to Moose Pond. Exposed roots are signs of erosion that has likely occurred over time.

Eroding trails or paths can be improved by reducing path width, using native plants, creating a meandering path, and covering the path with erosion control mulch. Steeper paths may need timber tiers and crushed stone to hold soil in place.
