Hancock and Sand Ponds Watershed Survey Report

**Cumberland County Soil and Water Conservation District
Hancock and Sand Ponds Association
Lakes Environmental Association
Maine Department of Environmental Protection**

April 2006

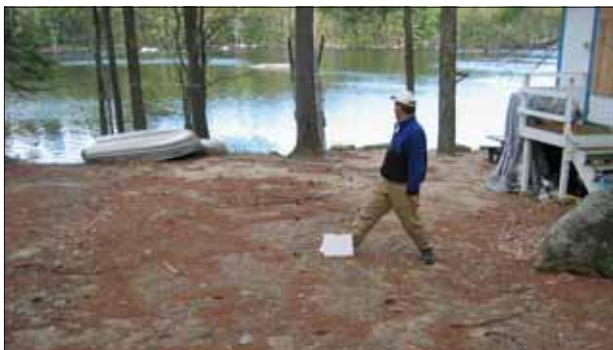
The fallen pine needles help slow some runoff at this residential site. However, native shrubs and ground covers should also be planted to better stabilize the soil.

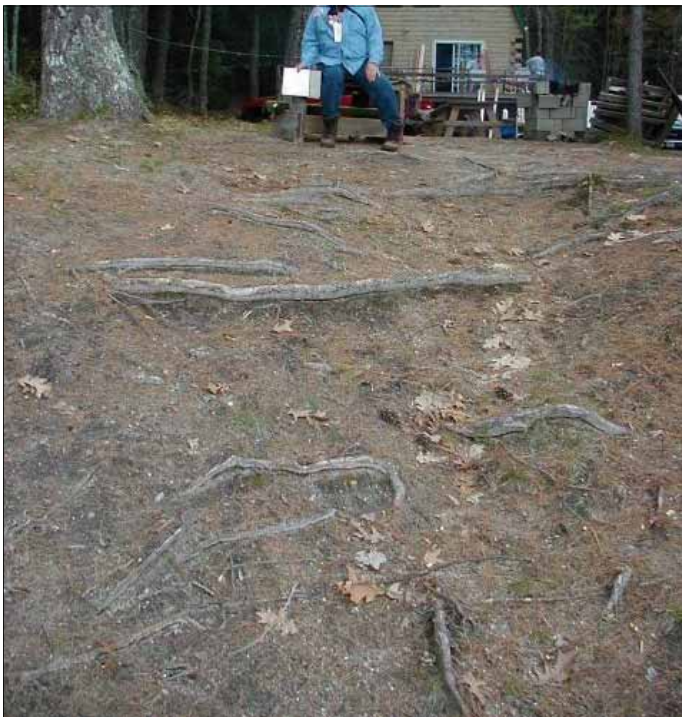
The erosion problems associated with the camp pictured below were common on many other properties within the watershed.

Problems:

- Shoreline erosion.
- Bare soil with severe surface erosion.
- Exposed tree roots.
- Direct flow of sediment to pond.

- Define stable foot path.
- Install infiltration steps.
- Stop raking.
- Plant native plants.
- Mulch bare areas.
- Seek proper permits from MDEP and Town.

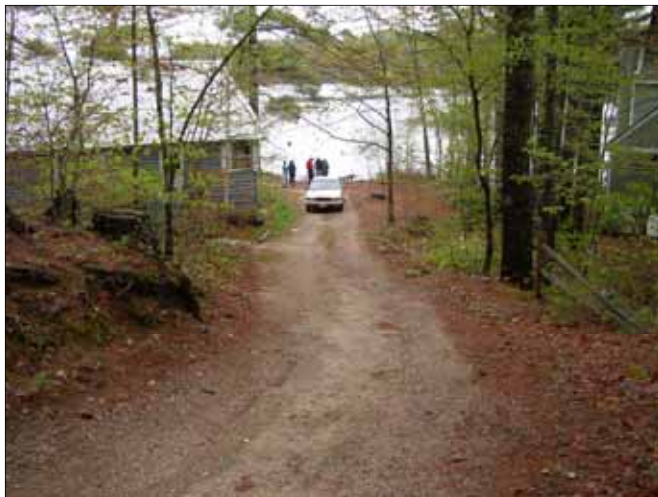
The erosion problems associated with the driveway pictured below were common on many other properties within the watershed.

Problems

- Moderate surface erosion.
- Direct flow of sediment to pond.
- Poor driveway shaping and ruts cause water to concentrate and erode the surface.

Preserve water quality and save time, money, and wear and tear on your vehicle by having a well crowned driveway. Use adequate surface material and add diverters to direct runoff into stable, vegetated areas.

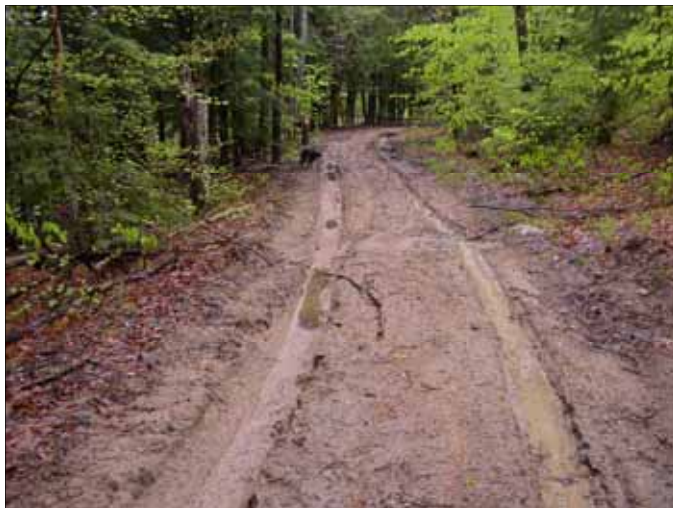
The erosion problems associated with the private road pictured below were common on many other roads within the watershed.

Problems:

- Poor road shaping.
- Poor surface material.
- Severe road surface erosion.
- Direct flow of road material to stream.

- Reshape and crown road.
- Add new surface material.
- Install runoff diverters to direct water to areas where it will infiltrate.

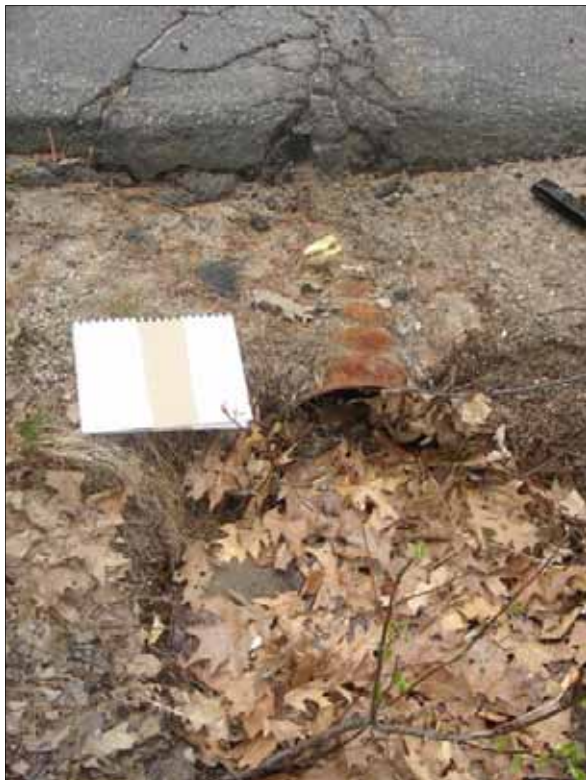
The erosion problems associated with the town road pictured below were common on many other roads throughout the watershed.

Problems:

- Unstable culvert inlet and outlet.
- Clogged culvert.
- Slight ditch erosion.
- Severe road shoulder erosion.
- Winter sand buildup.

- Vegetate or stabilize road shoulders
- Clean, reshape, and armor ditches with stone or vegetate with grass
- Clean out culverts, stabilize culvert inlets and outlets with stone, and install plunge pool
- Remove winter sand
- Install ditch turnouts

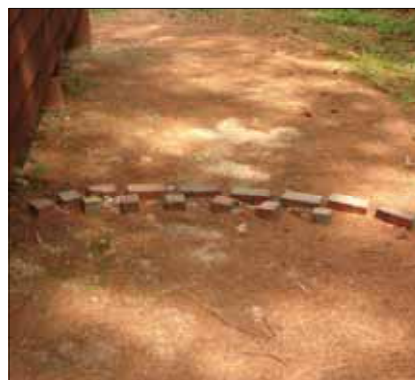
Survey teams identified many sites that showed good watershed protection techniques. These conservation practices included good vegetated buffers and well maintained driveways, roads, and ditches. The photo on the right depicts a creative way to slow the flow of water and allow it to spread out and infiltrate. The Maine DEP and Cumberland County SWCD have created numerous demonstration projects that showcase good watershed protection practices. Contact the Cumberland County SWCD, LEA or Maine DEP for more details.

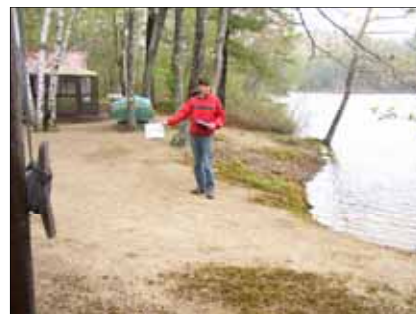
Planting native trees, shrubs, and groundcovers will help stabilize the soil, reduce erosion, while enhancing this property.

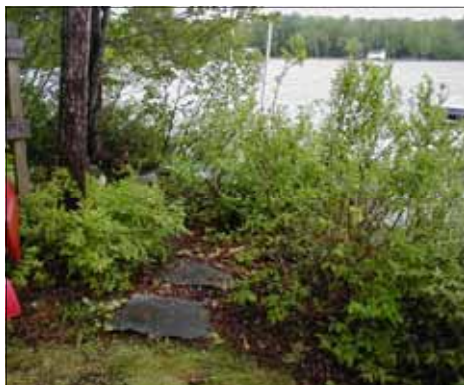
Often folks feel that once a buffer is in place, they will lose control of their access to the water - both physically and visually. Not so! Traffic can be directed by the use of appropriately placed shrubs and trees, which can be pruned so that views of the water are preserved. In fact, buffers can be designed to protect against noise and enhance privacy for lakefront residents. The photo at left shows an excellent example of a path to access the lake. The path winds through this buffer, minimizing the direct route for runoff to reach the lake.
